BUREAU OF SHIPS
TECHNICAL INSPECTION REPORT.

OPERATION CROSSROADS.
U.S.S. FALLON (APA 81).

TEST BAKER.

VOLUME 2 [U].

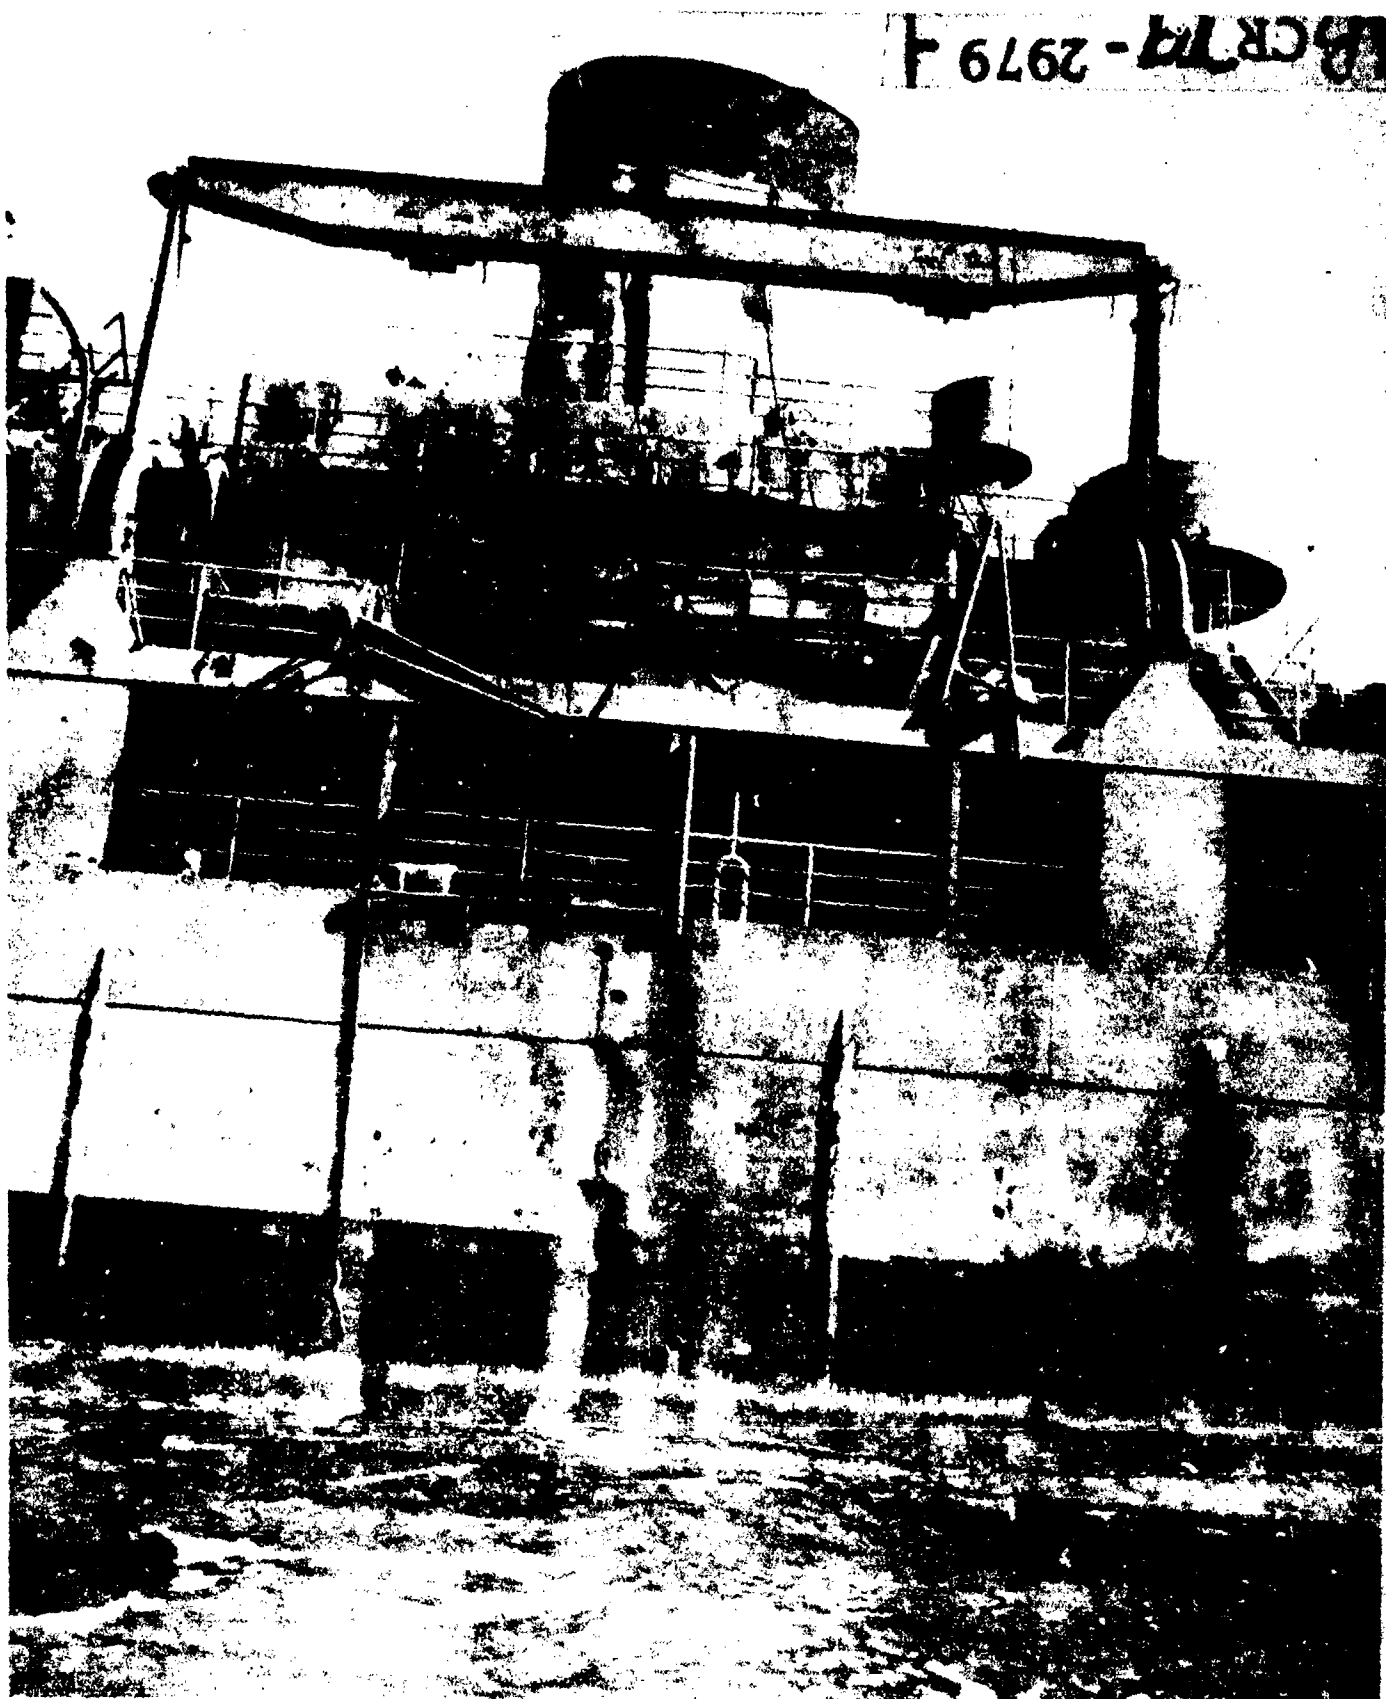
AB-CR-79-2979-9. Port side, frames 88 to 108, showing major structural failure.

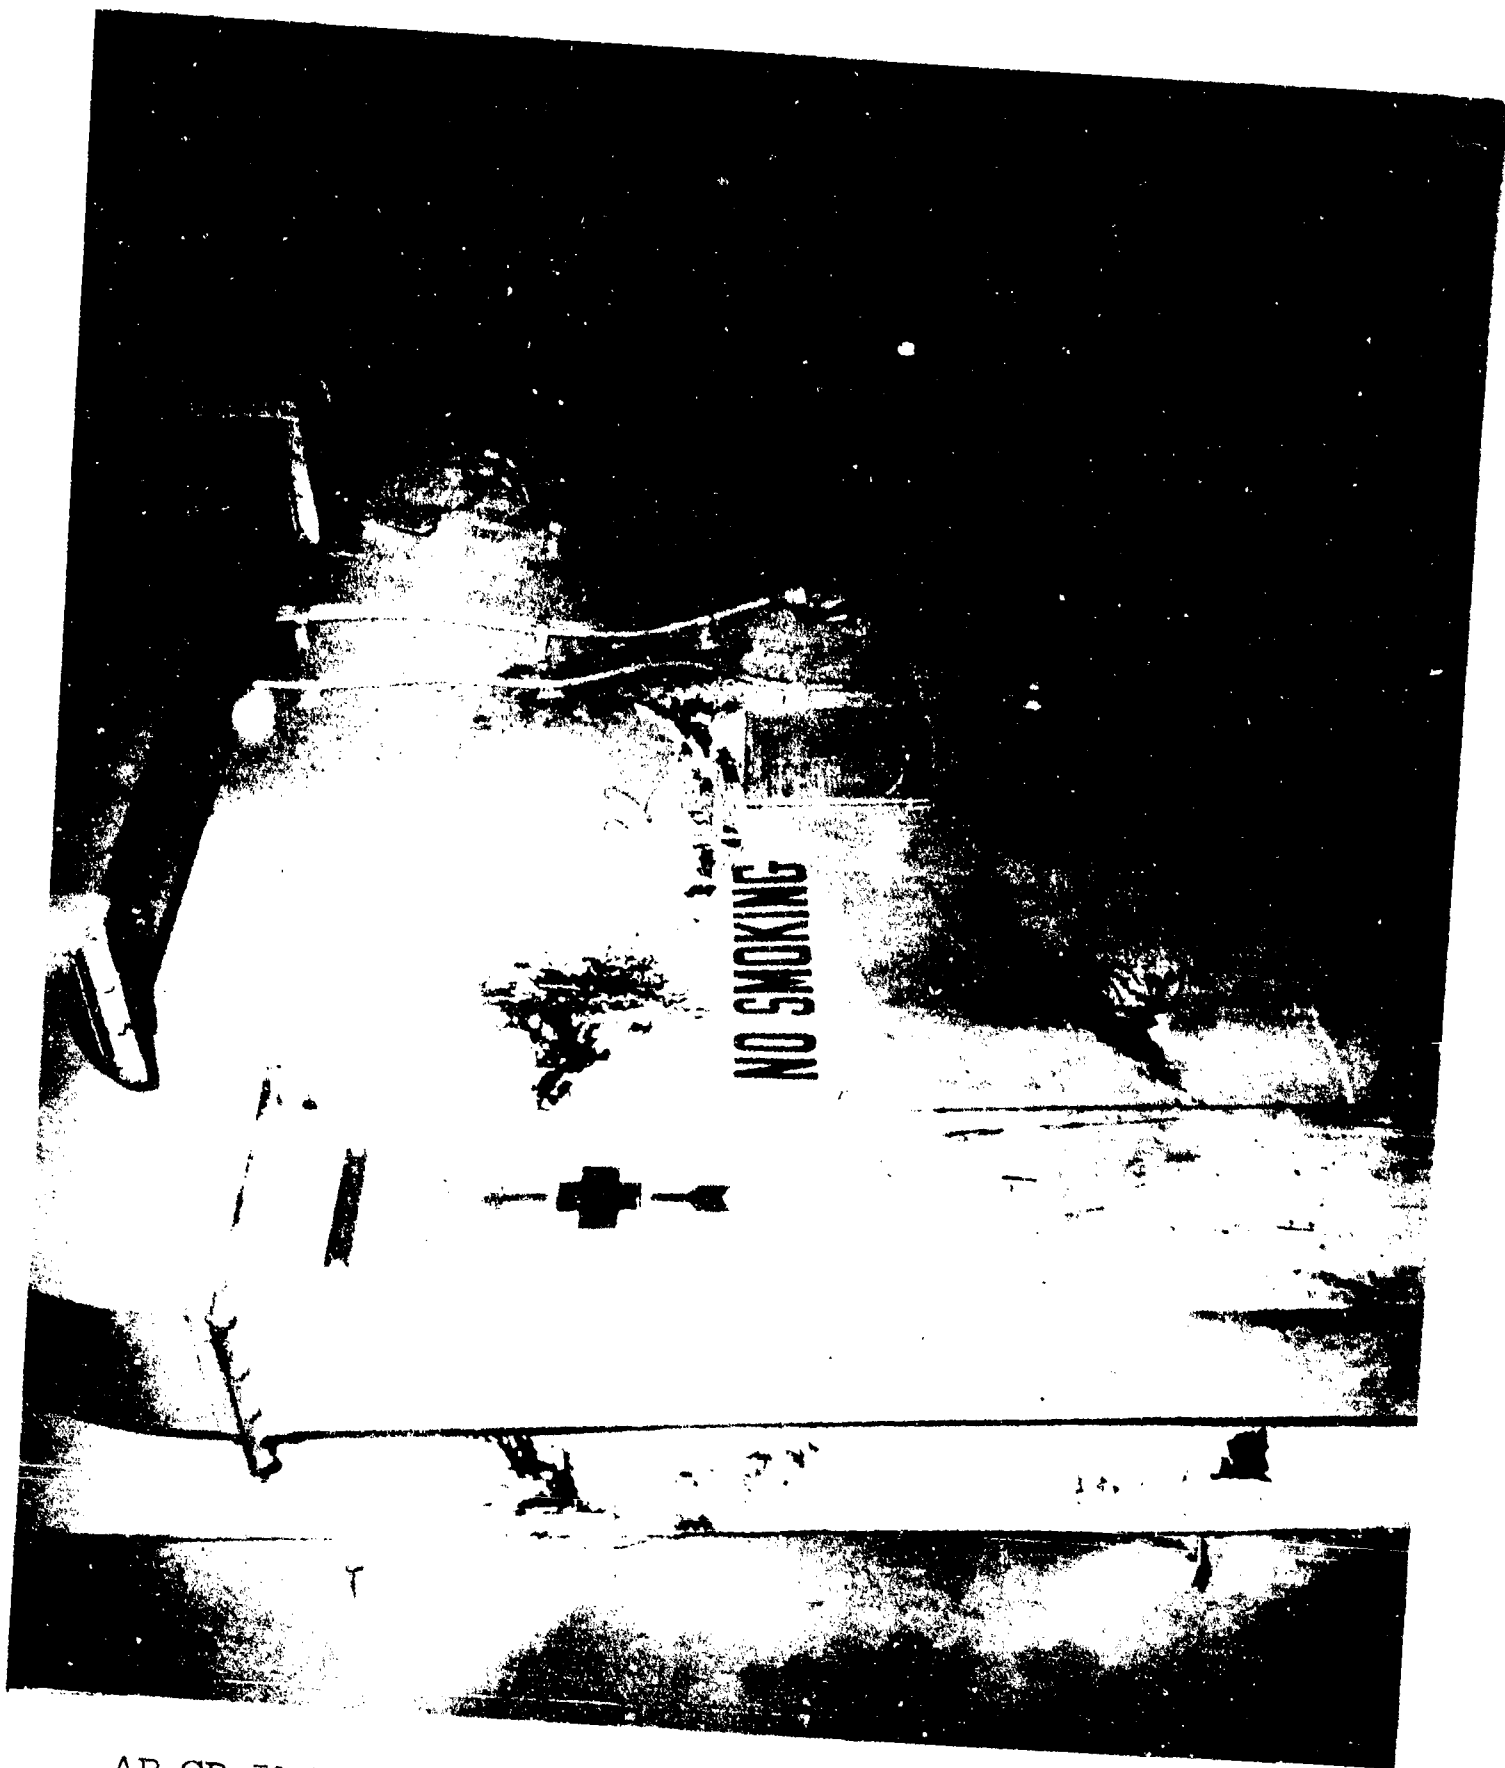
AB-CR-76-2527-3. Looking aft and to port in A-203A, first platform, showing damage to forward bulkhead 32 of locker and escape trunk, starboard.

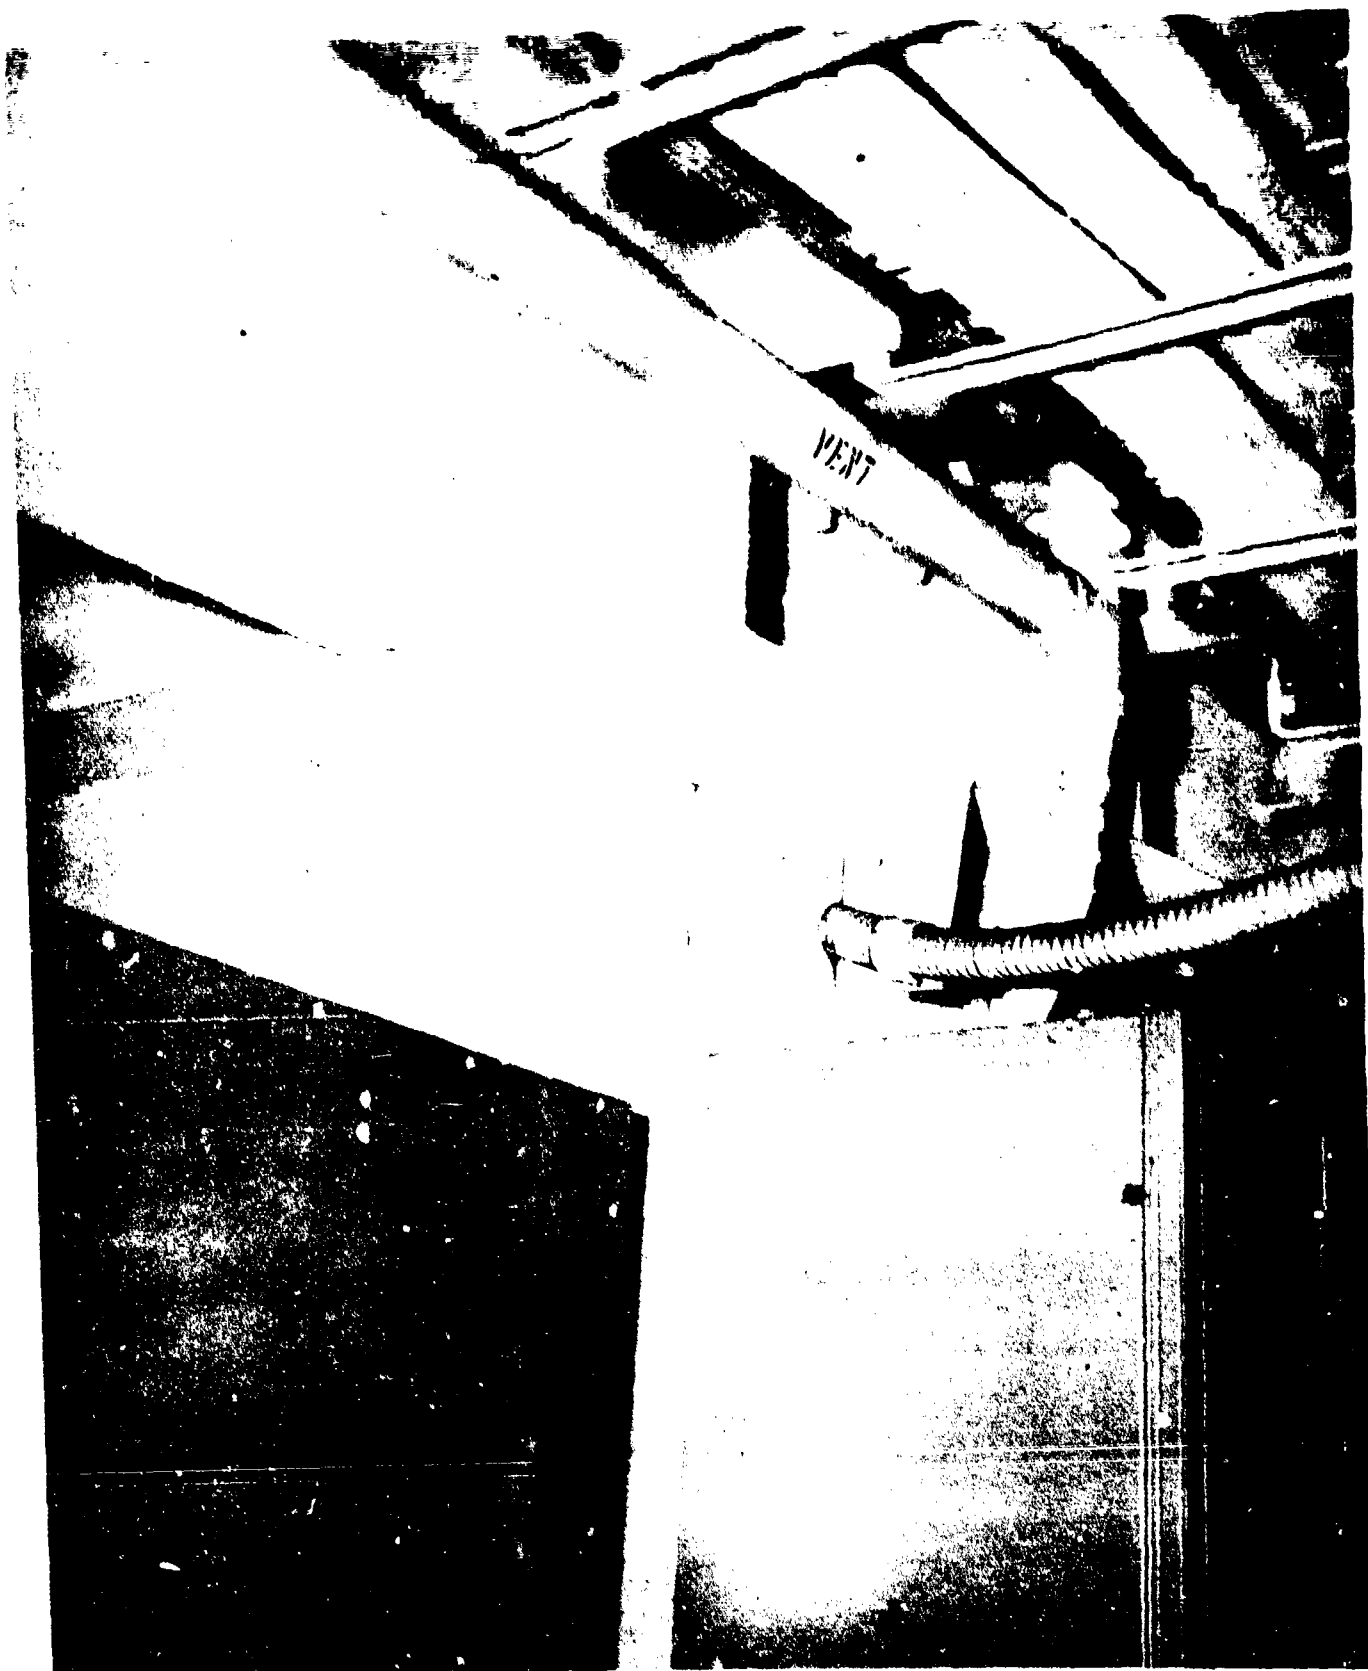
AB-CR-76-2218-9. A-103-3L. C.P.O. berthing, main deck, starboard side, looking forward and to port at damaged joiner bulkhead under starboard upper deck longitudinal girder, frame 35.

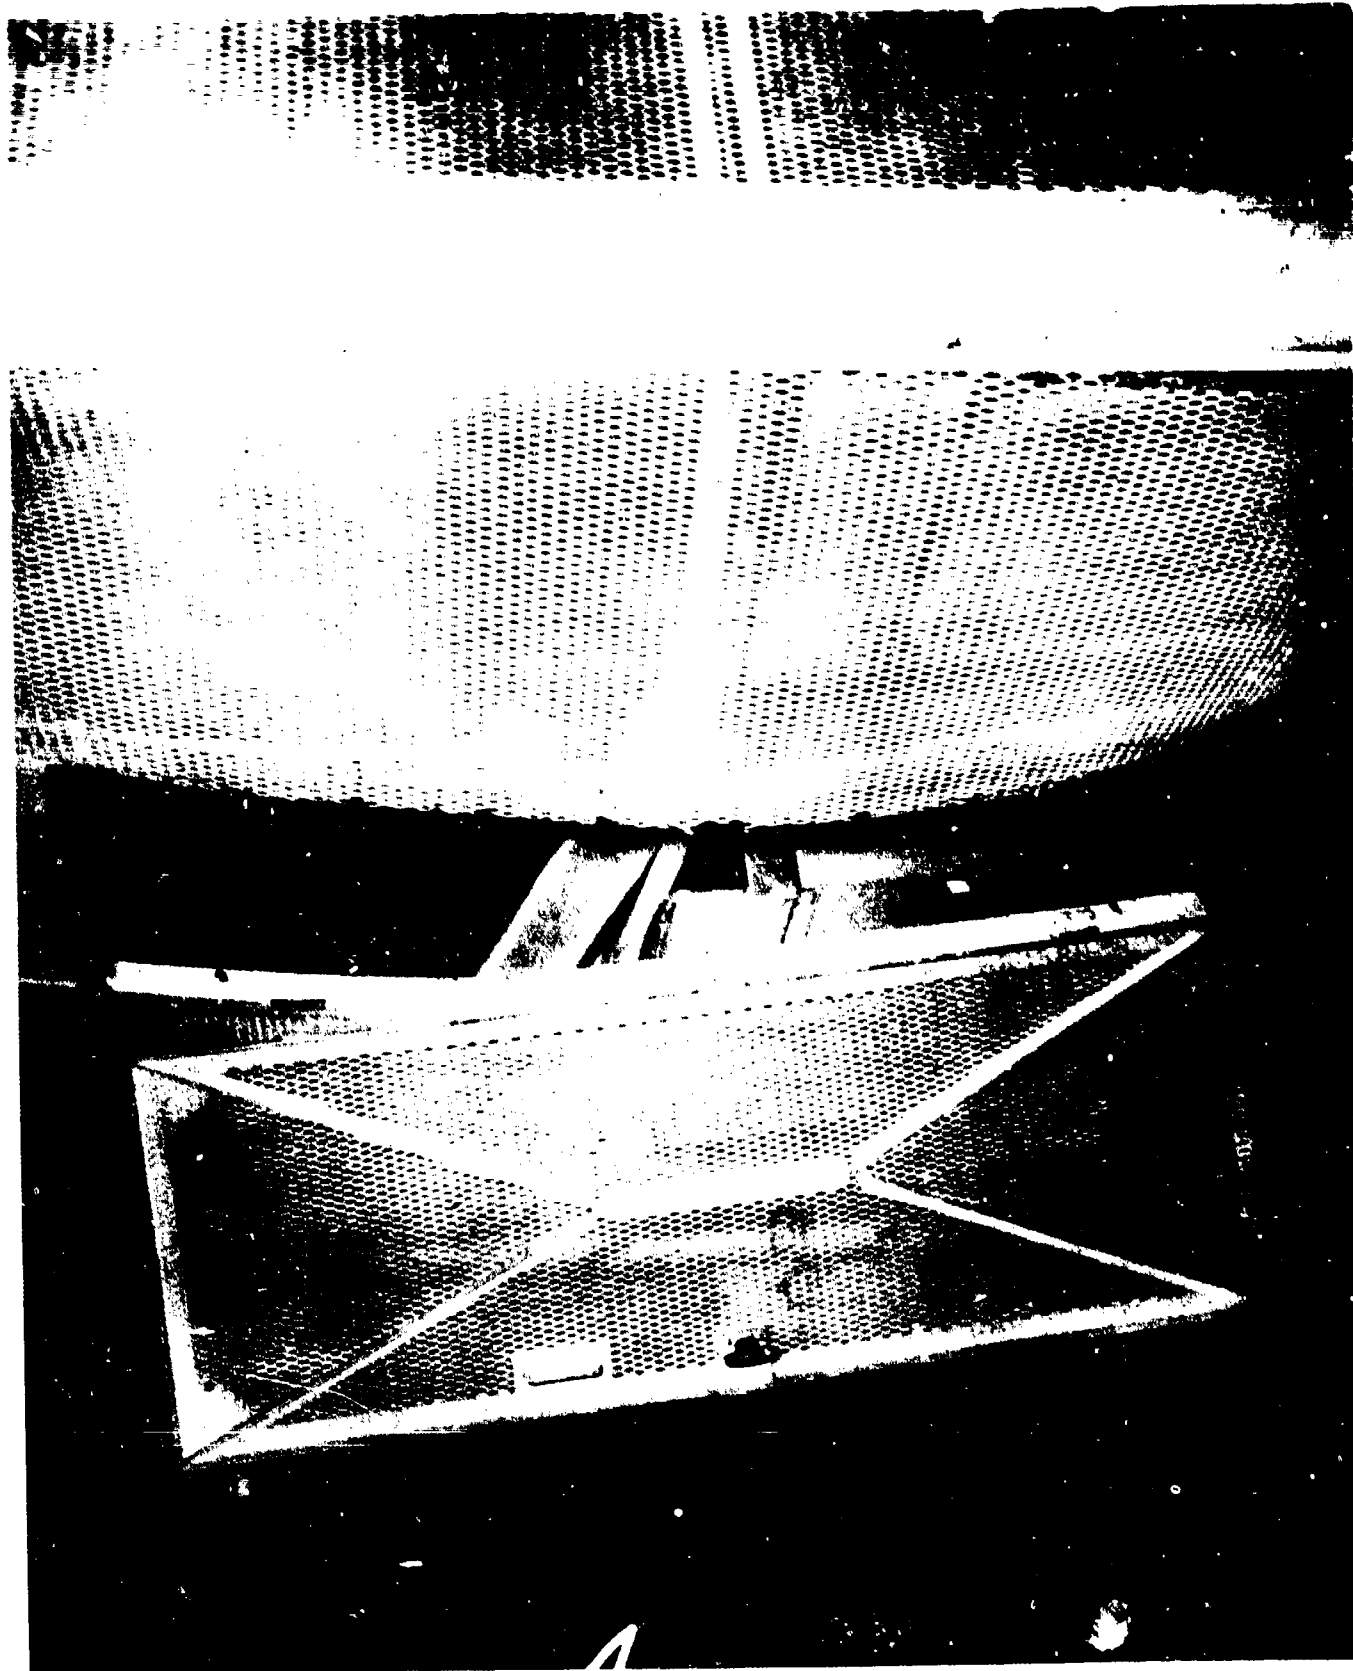
AB-CR-80-2196-4. B-102L. Damage to expanded metal bulkhead 65 at forward side of scullery, main deck, looking aft and to starboard.

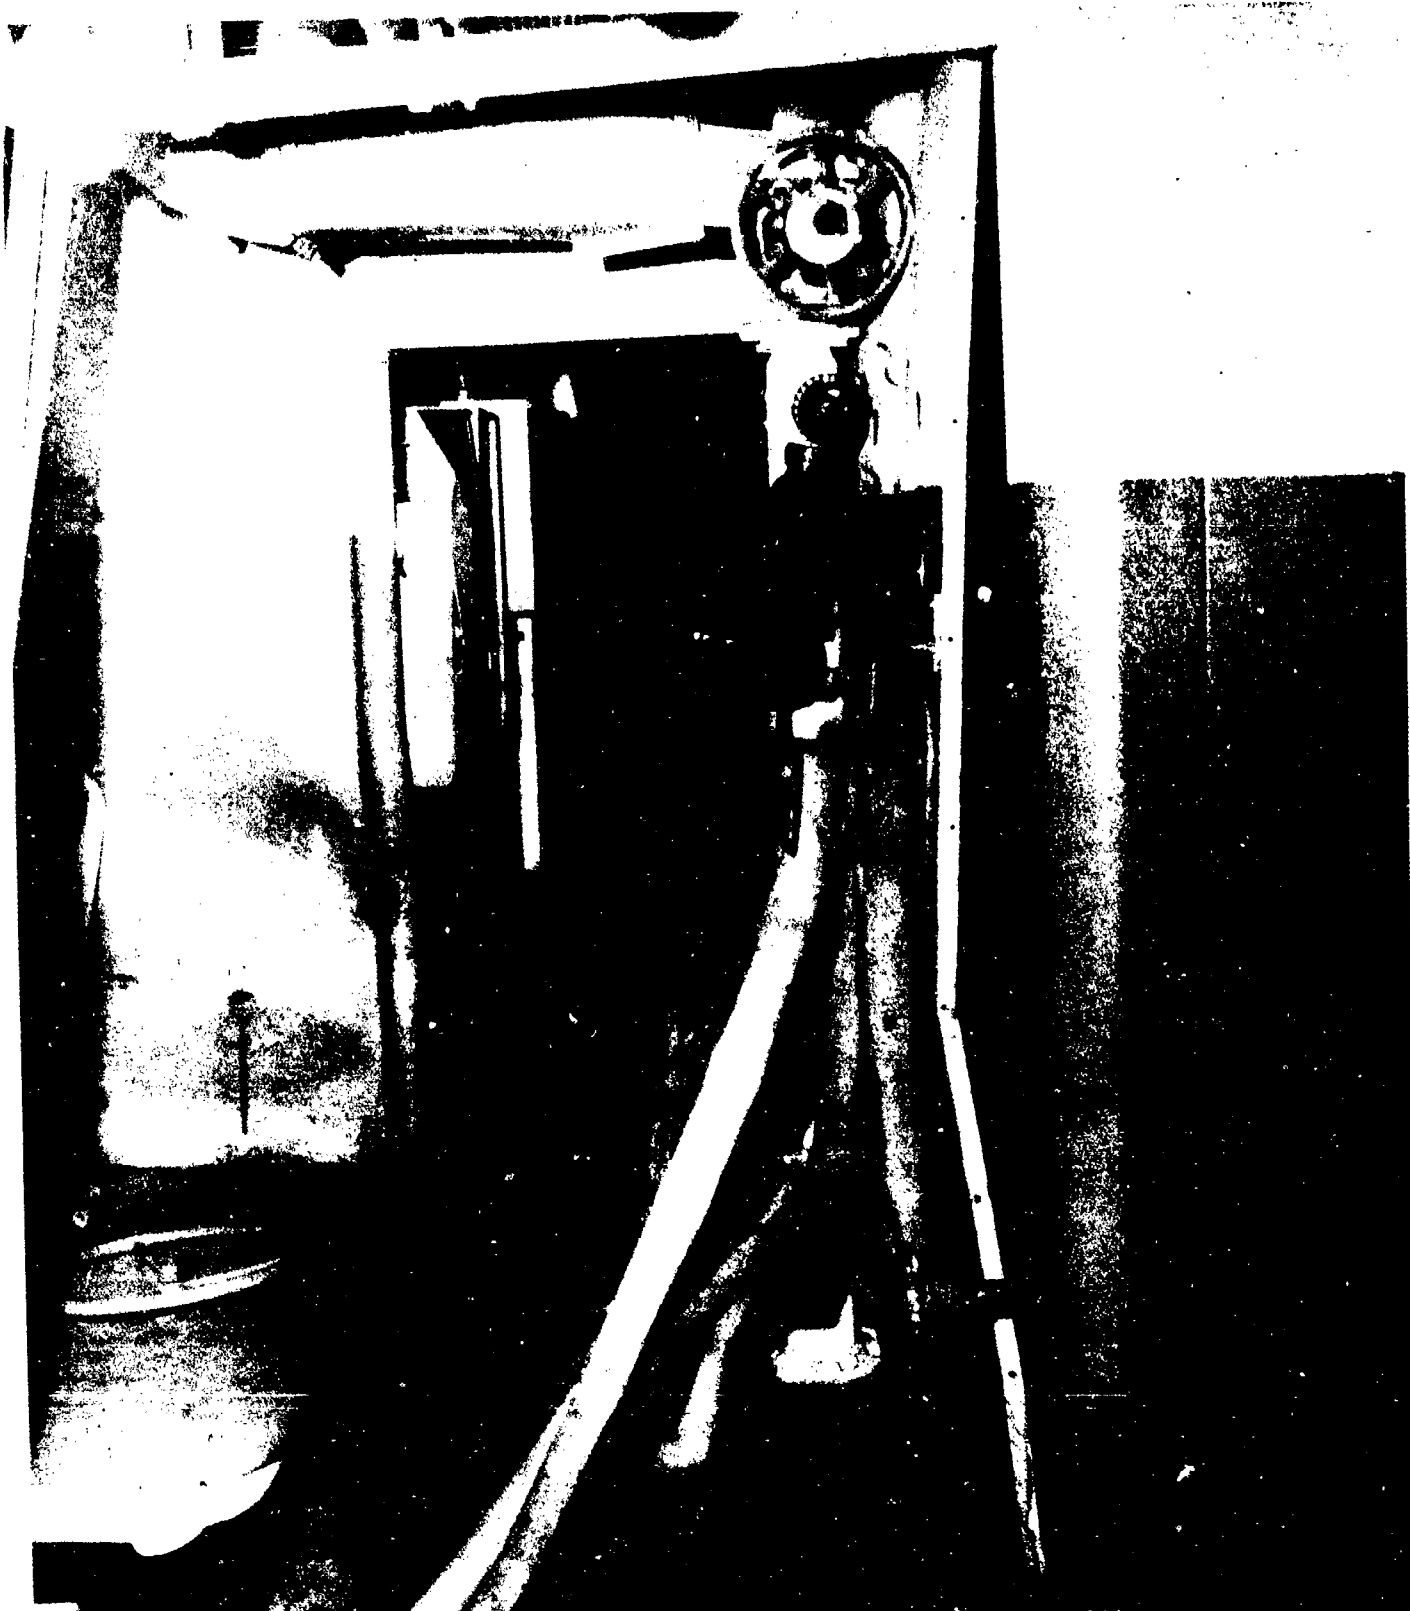
AB-CR-66-2880-11. Port passageway, main deck, looking forward from frame 88, showing damage to joiner bulkheads.

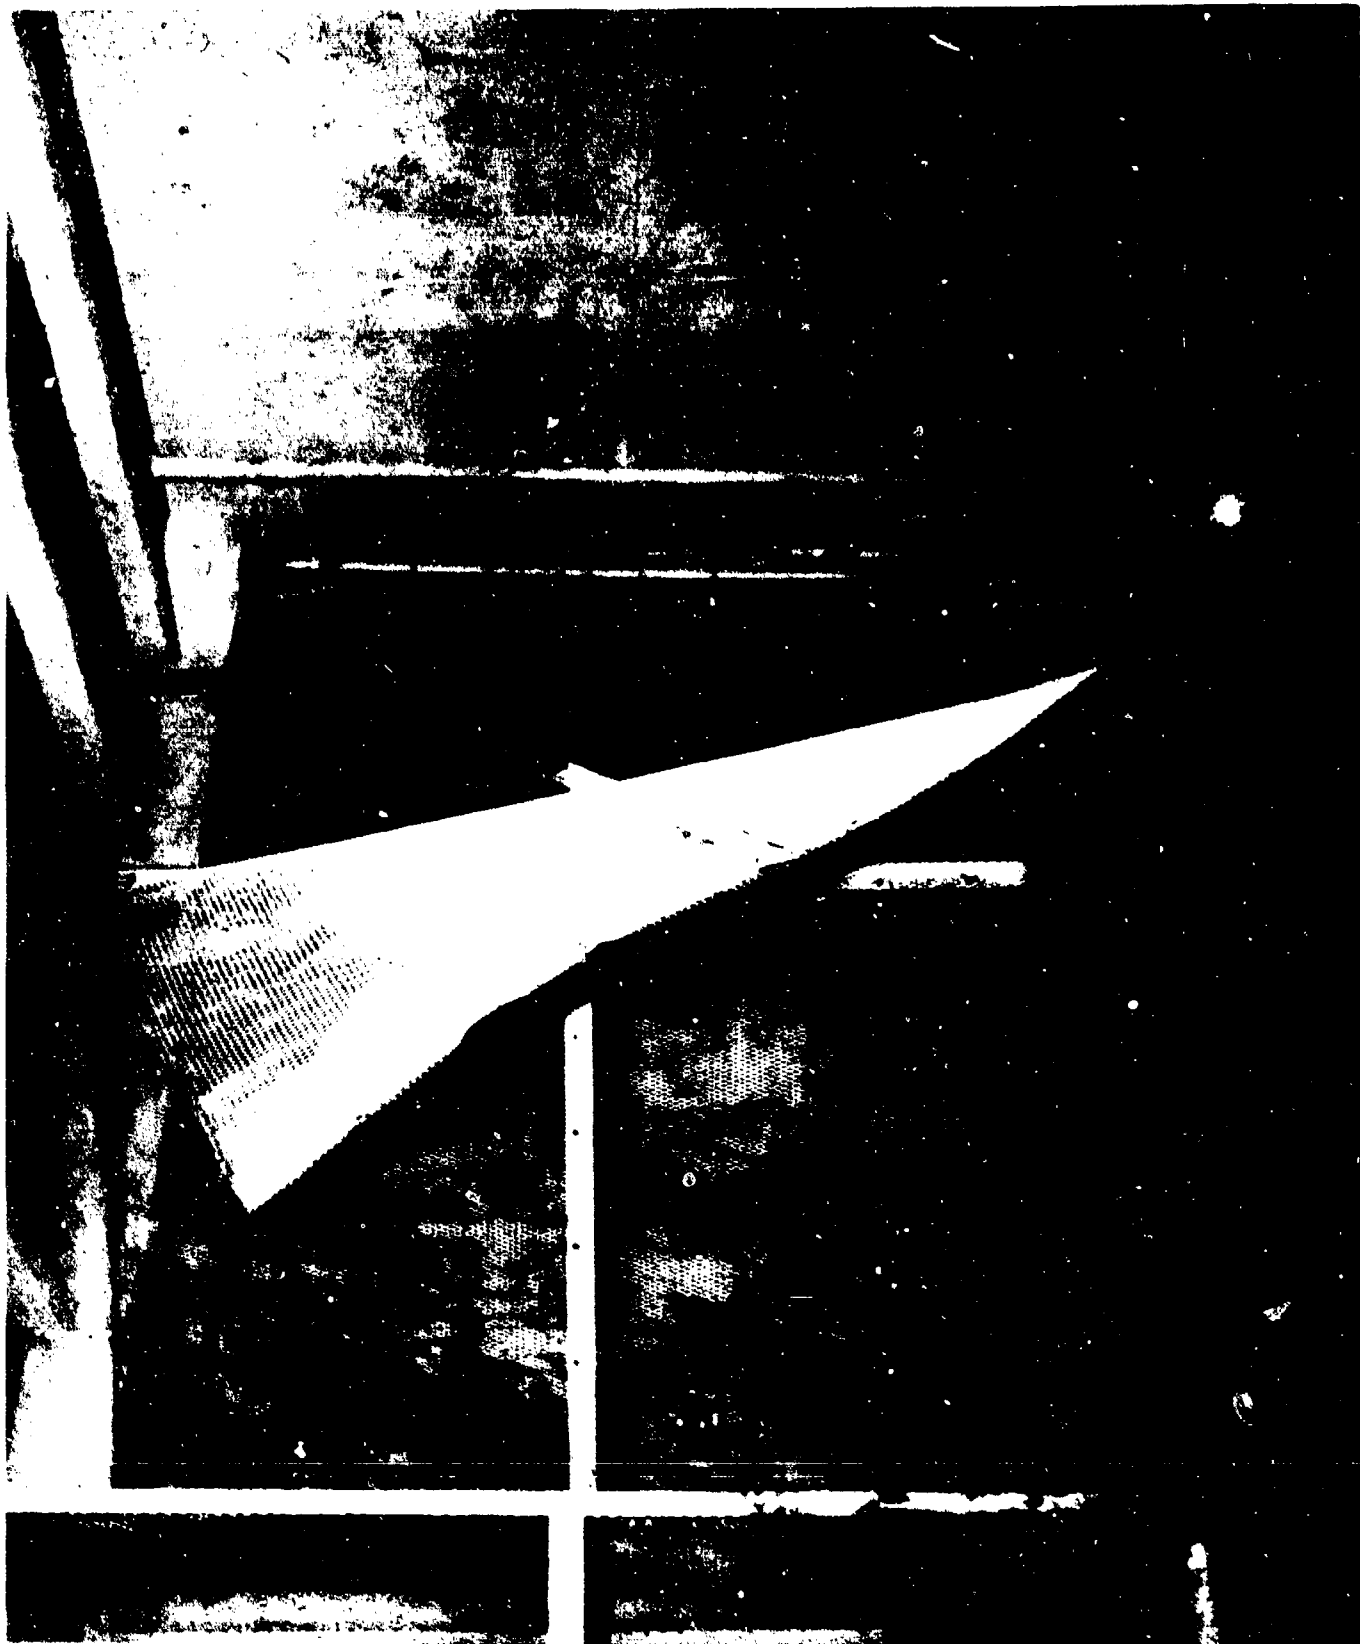
AB-CR-76-2218-6. C-301-A. S.D. stores, expanded metal bulkhead damaged by shifted cargo, looking forward and to port.

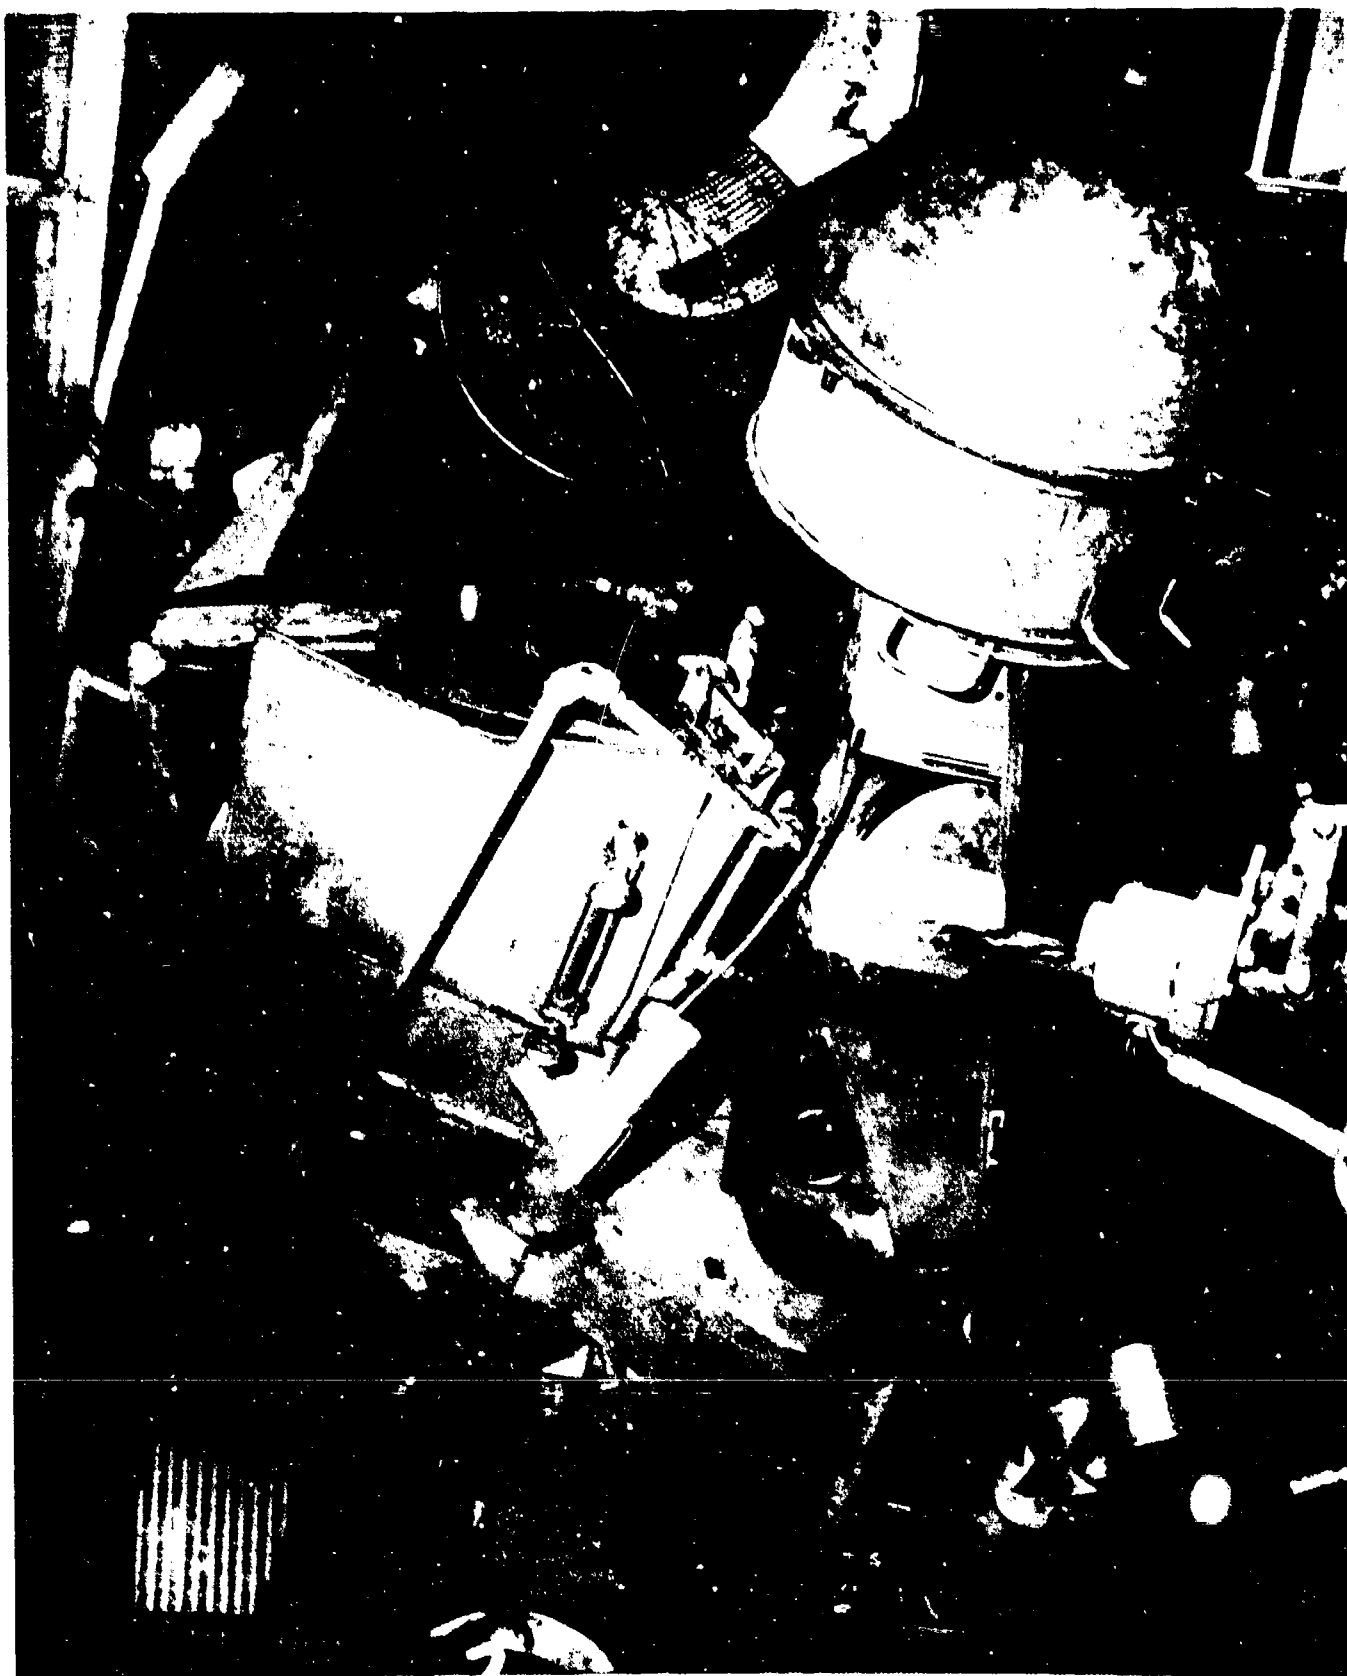
AB-CR-68-1789-2. B-102-L. Galley, main deck, looking to starboard and aft from frame 97, showing damage to equipment.

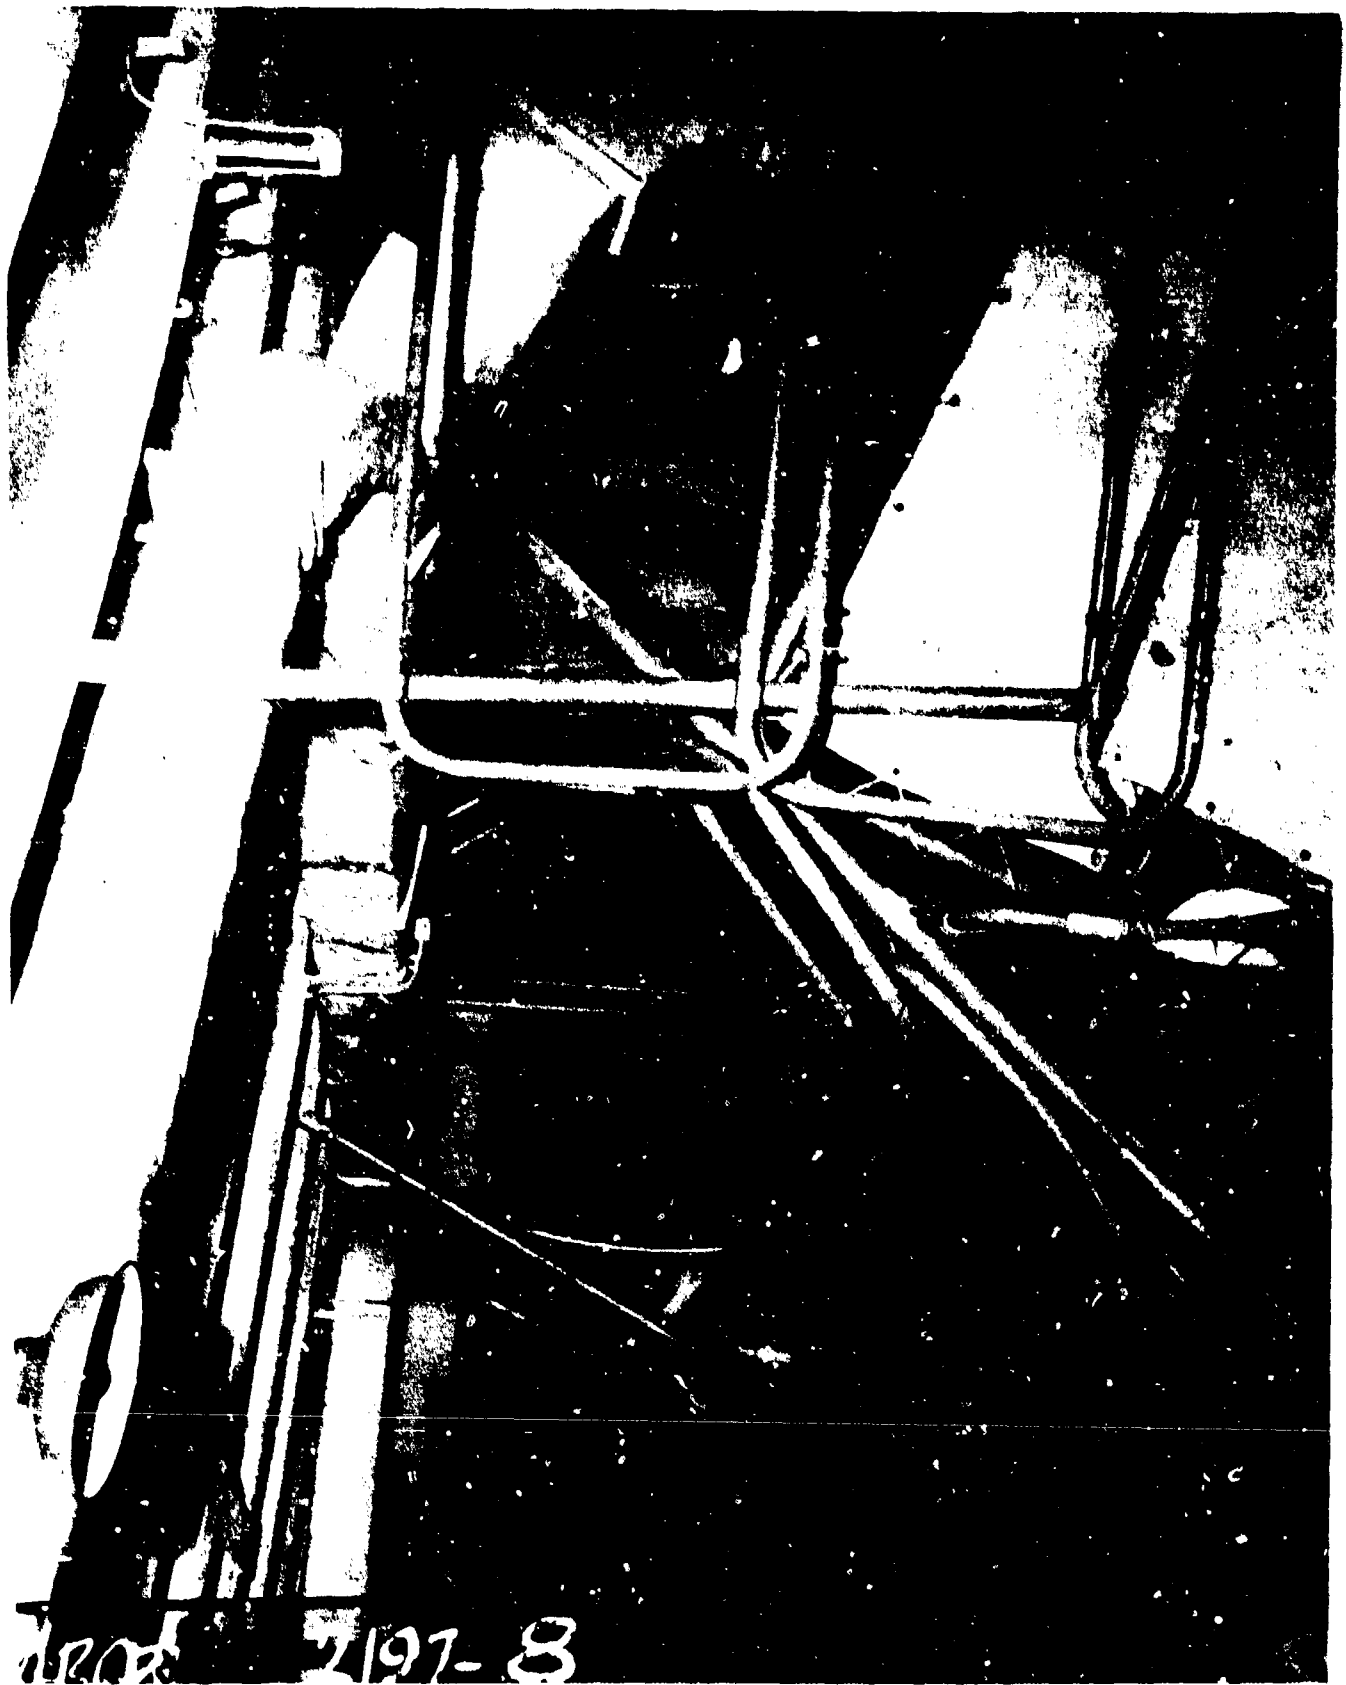
AB-CR-80-2197-8. A-104L. Looking forward and inboard on main deck, port side, in crews berthing, showing disarrangement of berths and damage to ventilation ducts. (Other side of joiner bulkhead appears in 2197-7.)

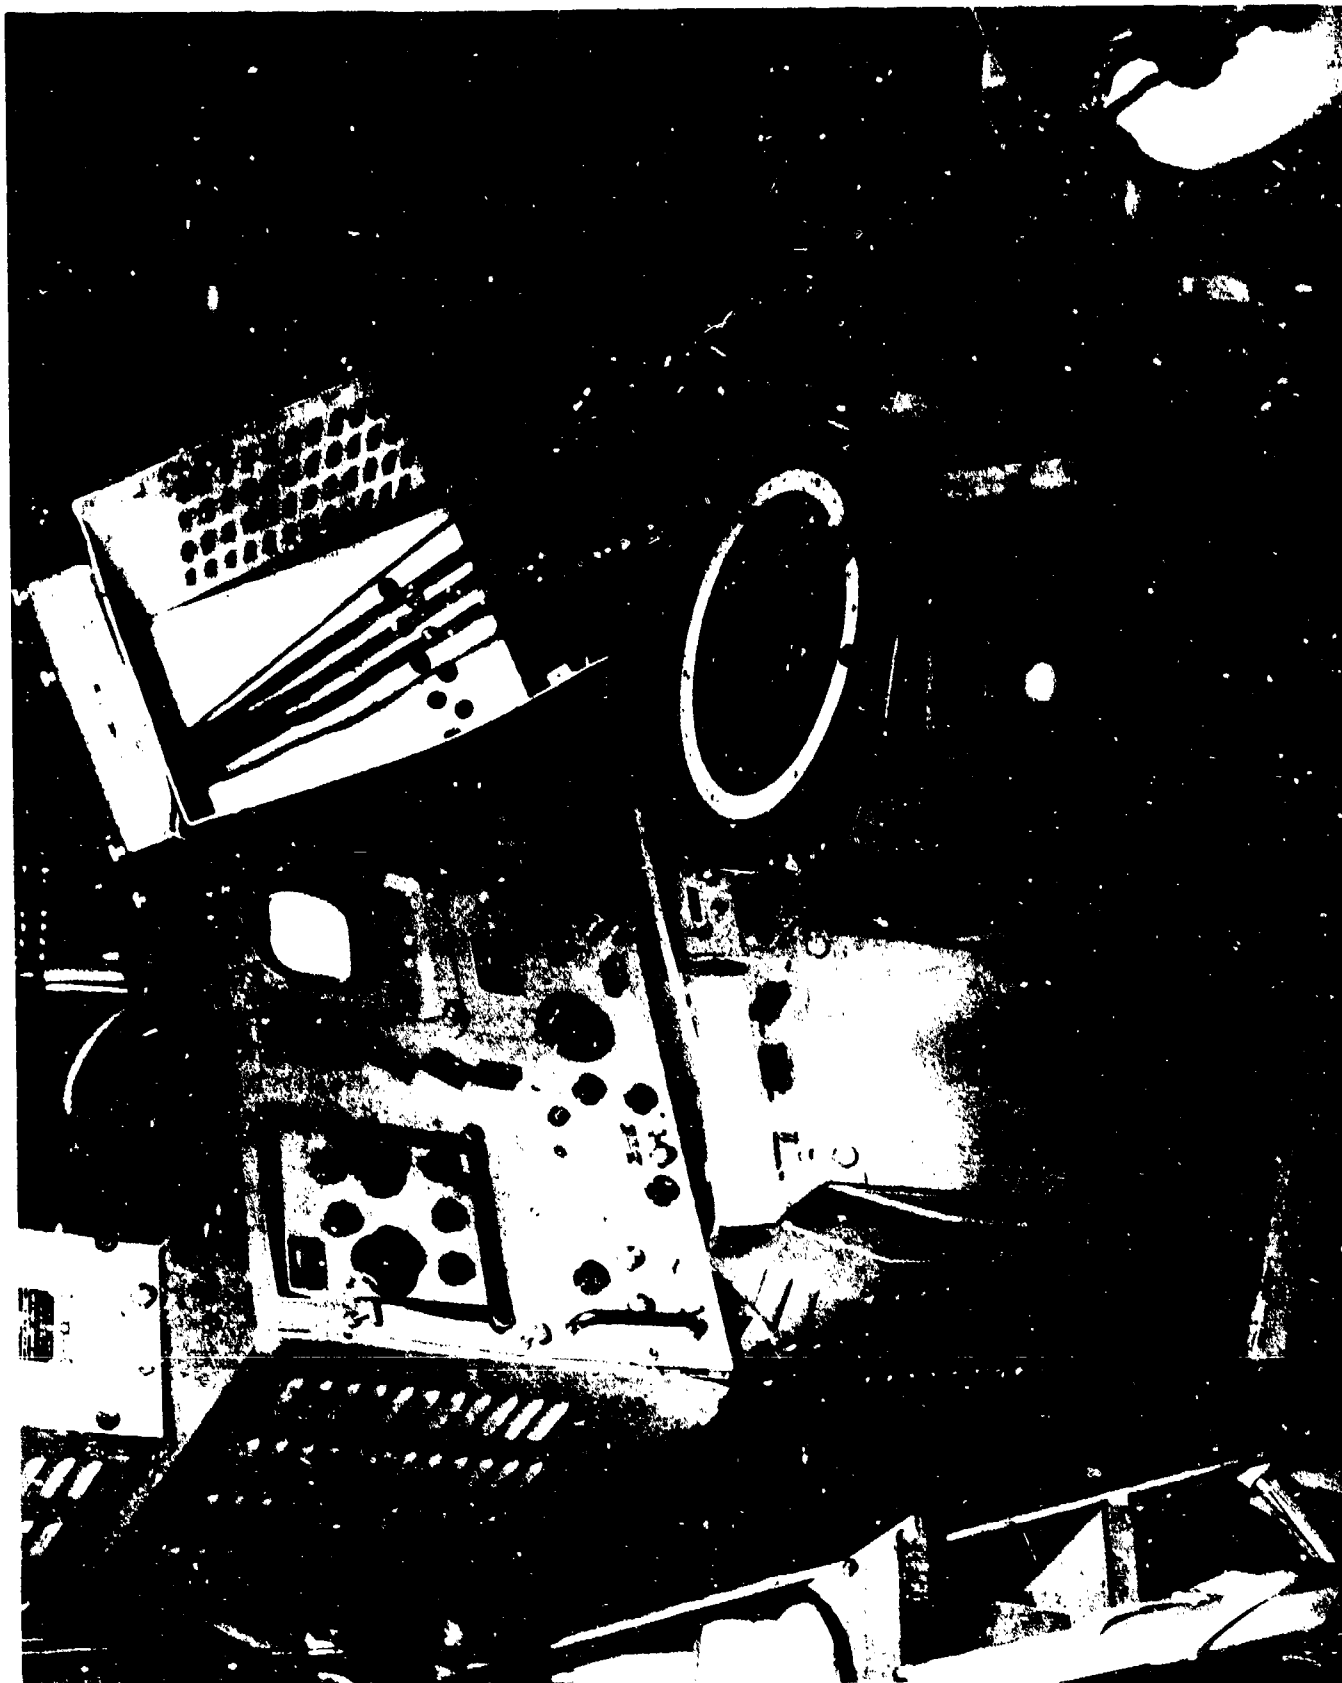
AB-CR-100-4206-5. View of general damage in C.I.C.
